Flood Control Project Maintenance
2014 Structure Summary Report
Overall Unit and Item Ratings

Turlock Irrigation District Gomes Lake

Gomes Lake Pumping Plant

Flood Control Project Maintenance**Unit Cover Sheet****2014 Pumping Plant Inspection Results****Turlock Irrigation District Gomes Lake**

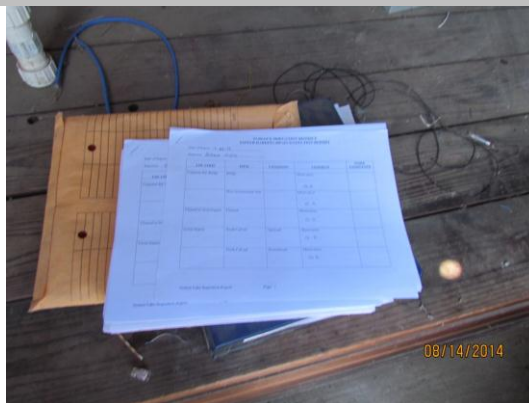
Photo 1 of 1 : ST_2014_NA0065_15_1_20140819_00020.jpg

LM Start	0.00	Rating **	A	Issue No.	1
LM End	0.00	Issue Type +	Ma	Location *	
Category	Pump Stations			GPS Latitude/Longitude	
				Start	End
Item	Operating Log			37.481567 °	37.481567 °
				-121.046617 °	-121.046617 °
DWR ID	DWR_NA0065_15_t_2012_1				
Action/Comments					
Inspector Comments: An operation log was present at the plant and the log was up to date.

View of the operating log.

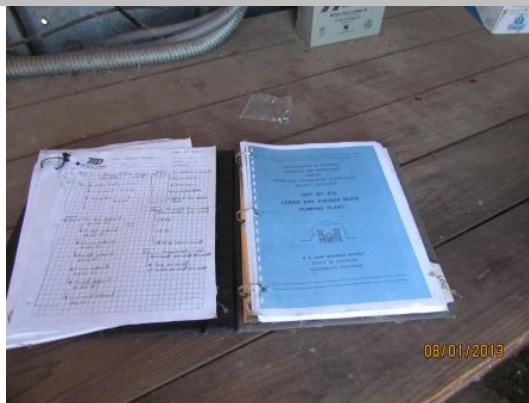
Photo 1 of 1 : ST_2014_NA0065_15_2_20140709_00002.jpg

LM Start	0.00	Rating **	A	Issue No.	2
LM End	0.00	Issue Type +	Ma	Location *	
Category	Pump Stations			GPS Latitude/Longitude	
				Start	End
Item	Operation & Maintenance Manual			37.481567 °	37.481567 °
				-121.046617 °	-121.046617 °
DWR ID	DWR_NA0065_15_t_2012_2				
Action/Comments					
Inspector Comments: The O&M manual was present at the plant.

View of the O&M manual inside the plant.

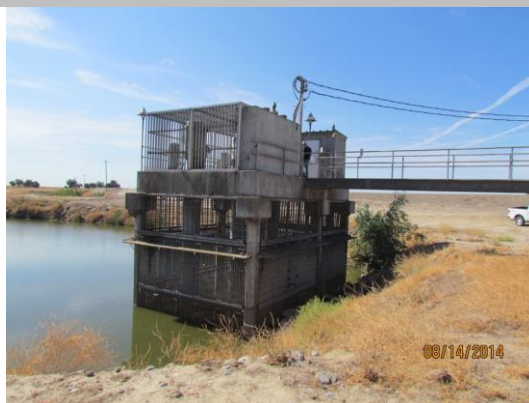
Photo 1 of 1 : ST_2014_NA0065_15_3_20140819_00021.jpg

LM Start	0.00	Rating **	A	Issue No.	3
LM End	0.00	Issue Type +	Ma	Location *	
Category	Pump Stations			GPS Latitude/Longitude	
				Start	End
Item	Plant Building			37.481567 °	37.481567 °
				-121.046617 °	-121.046617 °
DWR ID	DWR_NA0065_15_t_2012_3				
Action/Comments					
Inspector Comments: The plant building appeared to be in good structural condition with no major visible concrete damage.

View of the pumping plant.

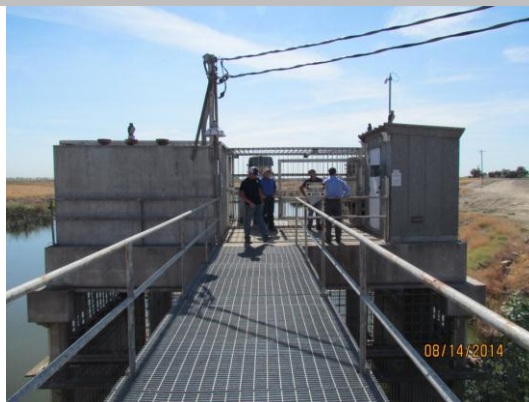
Photo 1 of 1 : ST_2014_NA0065_15_5_20140819_00022.jpg

LM Start	0.00	Rating **	A	Issue No.	5
LM End	0.00	Issue Type +	Ma	Location *	
Category	Pump Stations			GPS Latitude/Longitude	
				Start	End
Item	Safety			37.481567 °	37.481567 °
				-121.046617 °	-121.046617 °
DWR ID	DWR_NA0065_15_t_2012_5				
Action/Comments					
Inspector Comments: No significant safety hazard was observed at the plant during inspection. The lights were in working condition along with guard rails around the structure.

View of the guard rails around the pumping plant.

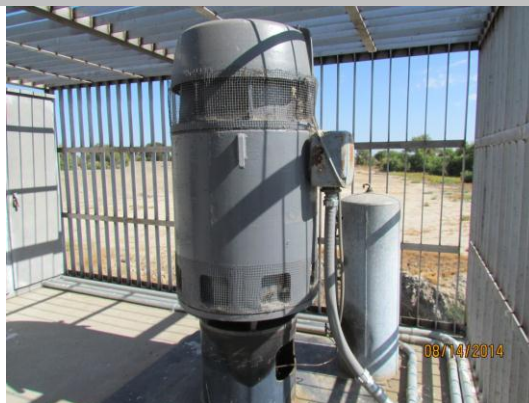
Photo 1 of 3 : ST_2014_NA0065_15_7_20140819_00023.jpg

LM Start	0.00	Rating **	A	Issue No.	7	
LM End	0.00	Issue Type +	Ma	Location *		
Category	Pump Stations			GPS Latitude/Longitude		
				Start	End	
Item	Pumps			37.481567 °	37.481567 °	
				-121.046617 °	-121.046617 °	
DWR ID	DWR_NA0065_15_t_2012_7					
Action/Comments						
Inspector Comments: All pumps were properly maintained and lubricated and they were periodically tested before the high water season.

View of one of the pumps.

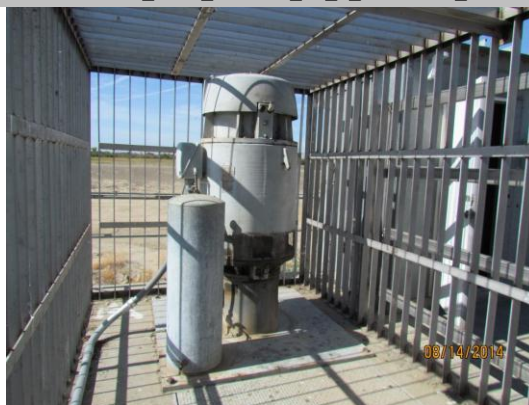
Photo 2 of 3 : ST_2014_NA0065_15_7_20140819_00024.jpg

View of another pump.

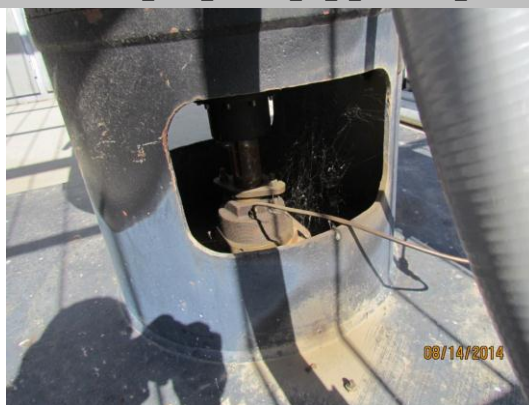
Photo 3 of 3 : ST_2014_NA0065_15_7_20140819_00025.jpg

View of bottom of a pump.

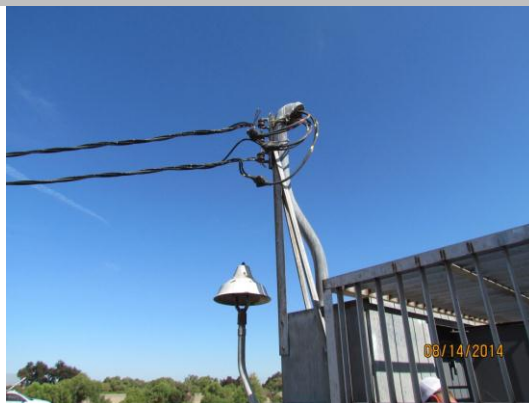
Photo 1 of 1 : ST_2014_NA0065_15_8_20140819_00026.jpg

LM Start	0.00	Rating **	A	Issue No.	8
LM End	0.00	Issue Type +	Ma	Location *	
Category	Pump Stations			GPS Latitude/Longitude	
				Start	End
Item	Power			37.481567 °	37.481567 °
				-121.046617 °	-121.046617 °
DWR ID	DWR_NA0065_15_t_2012_8				
Action/Comments					
Inspector Comments: The power source for this plant was delivered by

View of the power source at the plant.

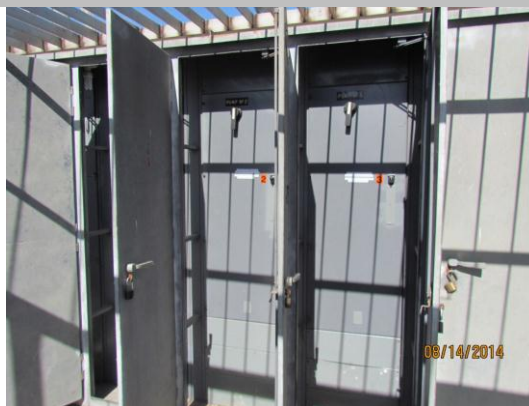
Photo 1 of 3 : ST_2014_NA0065_15_11_20140819_00027.jpg

LM Start	0.00	Rating **	A	Issue No.	11
LM End	0.00	Issue Type +	Ma	Location *	
Category	Pump Stations			GPS Latitude/Longitude	
				Start	End
Item	Pump Control Systems			37.481567 °	37.481567 °
				-121.046617 °	-121.046617 °
DWR ID	DWR_NA0065_15_t_2012_11				
Action/Comments					
Inspector Comments: The pump control system was operational and appeared to be free of any damage or corrosion.

View of the one of the pump power control boxes.

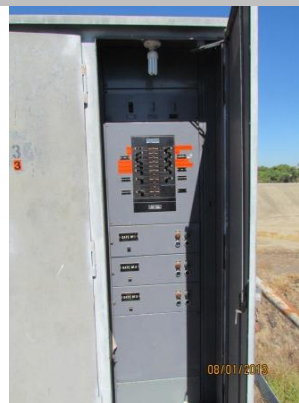
Photo 2 of 3 : ST_2014_NA0065_15_11_20140709_00009.jpg

LM Start	0.00	Rating **	A	Issue No.	11 (cont)	
LM End	0.00	Issue Type +	Ma	Location *		
Category	Pump Stations			GPS Latitude/Longitude		
				Start	End	
Item	Pump Control Systems			37.481567 °	37.481567 °	
				-121.046617 °	-121.046617 °	
DWR ID	DWR_NA0065_15_t_2012_11					
Action/Comments						
Inspector Comments: The pump control system was operational and appeared to be free of any damage or corrosion.

View of the power switch system.

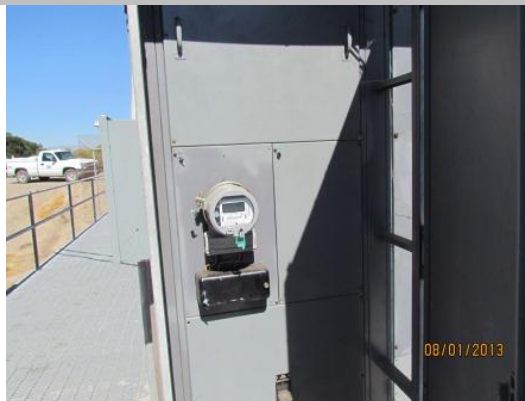
Photo 3 of 3 : ST_2014_NA0065_15_11_20140709_00010.jpg

View of the power meter.

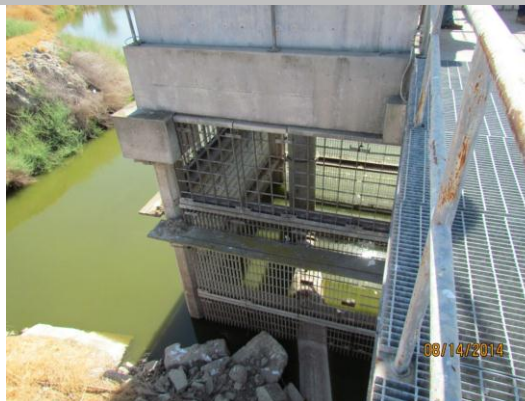
Photo 1 of 1 : ST_2014_NA0065_15_12_20140819_00028.jpg

LM Start	0.00	Rating **	A	Issue No.	12
LM End	0.00	Issue Type +	Ma	Location *	
Category	Pump Stations			GPS Latitude/Longitude	
				Start	End
Item	Sumps/Wet Well			37.481567 °	37.481567 °
				-121.046617 °	-121.046617 °
DWR ID	DWR_NA0065_15_t_2012_12				
Action/Comments					
Inspector Comments: The wet well was clear of excessive debris and

View of the wet well.

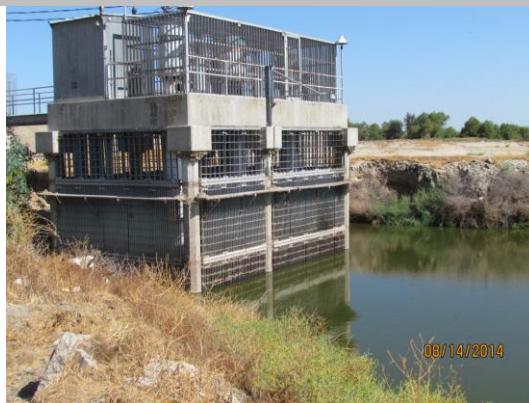
Photo 1 of 1 : ST_2014_NA0065_15_13_20140819_00029.jpg

LM Start	0.00	Rating **	A	Issue No.	13
LM End	0.00	Issue Type +	Ma	Location *	
Category	Pump Stations			GPS Latitude/Longitude	
				Start	End
Item	Trash Racks			37.481567 °	37.481567 °
				-121.046617 °	-121.046617 °
DWR ID	DWR_NA0065_15_t_2012_13				
Action/Comments					
Inspector Comments: The trash racks were free of debris and appeared to be maintained properly.

View of the trash racks.

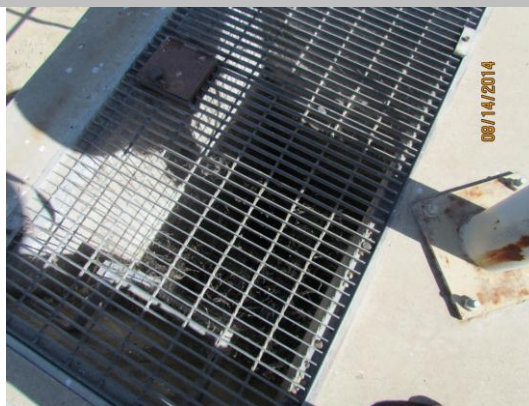
Photo 1 of 1 : ST_2014_NA0065_15_15_20140819_00030.jpg

LM Start	0.00	Rating **	A	Issue No.	15
LM End	0.00	Issue Type +	Ma	Location *	
Category	Pump Stations			GPS Latitude/Longitude	
				Start	End
Item	Sluice / Slide Gates			37.481567 °	37.481567 °
				-121.046617 °	-121.046617 °
DWR ID	DWR_NA0065_15_t_2012_15				
Action/Comments					
Inspector Comments: The slide gates were free of any debris and appeared to be in good working condition.

View of the slide gate from the top of the structure.

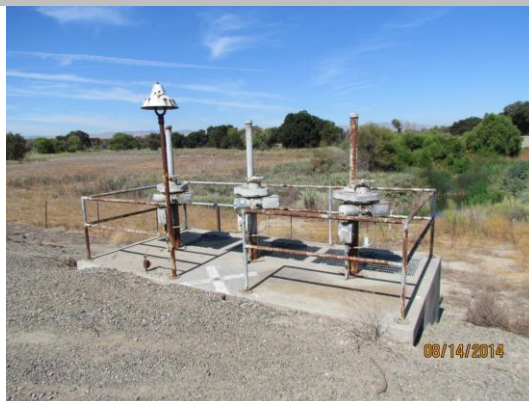
Photo 1 of 1 : ST_2014_NA0065_15_17_20140819_00031.jpg

LM Start	0.00	Rating **	A	Issue No.	17
LM End	0.00	Issue Type +	Ma	Location *	
Category	Pump Stations			GPS Latitude/Longitude	
				Start	End
Item	Manual Gate Operators			37.481567 °	37.481567 °
				-121.046617 °	-121.046617 °
DWR ID	DWR_NA0065_15_t_2012_17				
Action/Comments					
Inspector Comments: Manual gate operators appeared to be operational and capable of opening and closing the gate properly.

View of the manual gates.

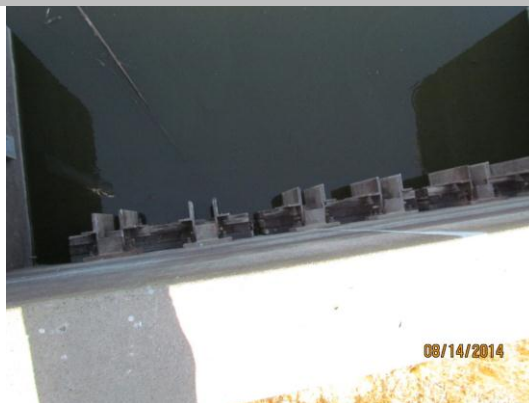
Photo 1 of 1 : ST_2014_NA0065_15_19_20140819_00032.jpg

LM Start	0.00	Rating **	A	Issue No.	19
LM End	0.00	Issue Type +	Ma	Location *	
Category	Pump Stations			GPS Latitude/Longitude	
				Start	End
Item	Flap Gates			37.481567 °	37.481567 °
				-121.046617 °	-121.046617 °
DWR ID	DWR_NA0065_15_t_2012_19				
Action/Comments					
Inspector Comments: The flap gates appeared to be in good working condition and capable of performing as intended.

View of the flap gates.

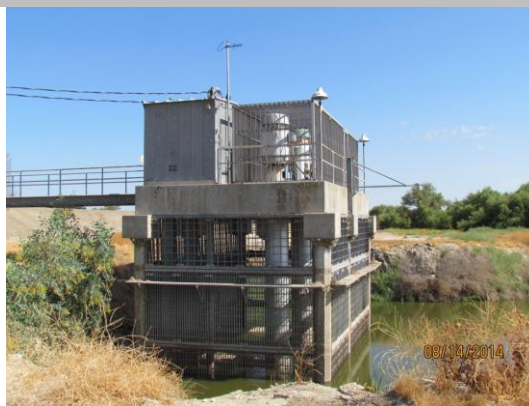
Photo 1 of 3 : ST_2014_NA0065_15_21_20140819_00034.jpg

LM Start	0.00	Rating **	A	Issue No.	21
LM End	0.00	Issue Type +	Ma	Location *	
Category	Pump Stations			GPS Latitude/Longitude	
				Start	End
Item	Security Fencing			37.481567 °	37.481567 °
				-121.046617 °	-121.046617 °
DWR ID	DWR_NA0065_15_t_2012_21				
Action/Comments					
Inspector Comments: The security fencing appeared to be in good condition and should provide protection against unauthorized access.

View of the new steel cage around the pumps during 2014 inspection.

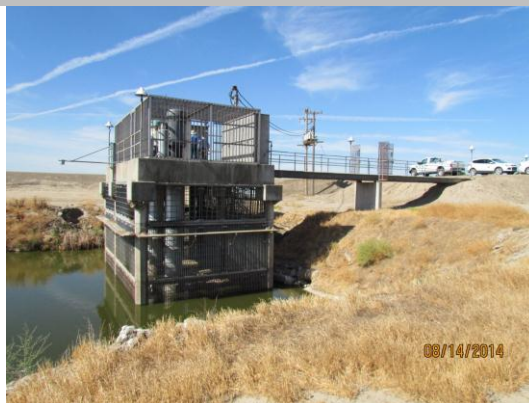
Photo 2 of 3 : ST_2014_NA0065_15_21_20140819_00033.jpg

LM Start	0.00	Rating **	A	Issue No.	21 (cont)
LM End	0.00	Issue Type +	Ma	Location *	
Category	Pump Stations			GPS Latitude/Longitude	
				Start	End
Item	Security Fencing			37.481567 °	37.481567 °
				-121.046617 °	-121.046617 °
DWR ID	DWR_NA0065_15_t_2012_21				
Action/Comments					
Inspector Comments: The security fencing appeared to be in good condition and should provide protection against unauthorized access.

View of the new steel cage around the pumps during 2014 inspection.

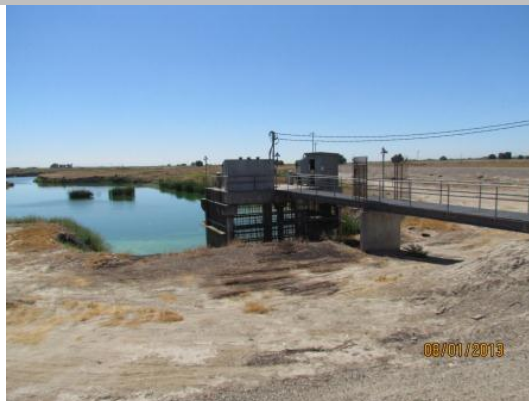
Photo 3 of 3 : ST_2014_NA0065_15_21_20140709_00019.jpg

View of the fences around the pumping plant during 2013 inspection.

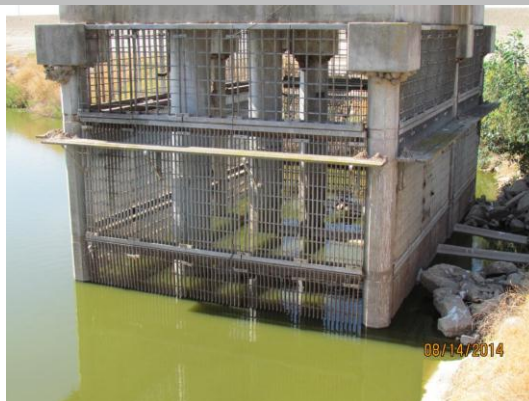
Photo 1 of 1 : ST_2014_NA0065_15_22_20140819_00035.jpg

LM Start	0.00	Rating **	A	Issue No.	22
LM End	0.00	Issue Type +	Ma	Location *	
Category	Pump Stations			GPS Latitude/Longitude	
				Start	End
Item	Intake and Discharge Pipes			37.481567 °	37.481567 °
				-121.046617 °	-121.046617 °
DWR ID	DWR_NA0065_15_t_2012_22				
Action/Comments					
Inspector Comments: The intake and discharge pipes appeared to be

View of the intake pipes.
